**ON-SITE AIR BAG INVESTIGATION**

**CASE NO. - 94-11**  
**FLEET - RENTAL VEHICLE**  
**LOCATION - [REDACTED] INDIANA**  
**ACCIDENT DATE - [REDACTED] 1994**

**Contract Number: DTNH22-94-D-17058**

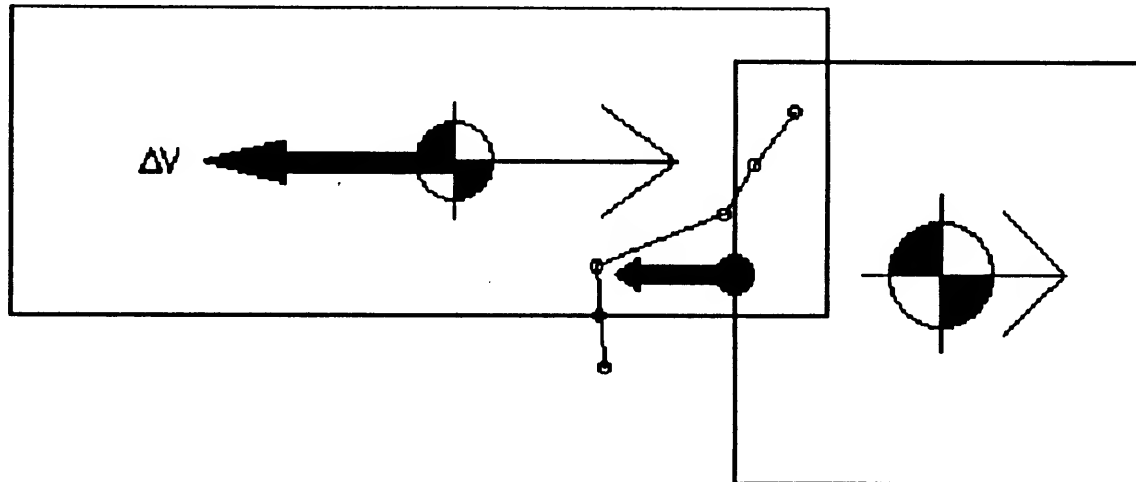
EDCRASH  
Damage Profiles

Crush Data (in):	
W	61.0	0.0
D	18.5	0.0
C1	7.8	0.0
C2	17.7	0.0
C3	25.0	0.0
C4	55.5	0.0
C5	54.8	
C6	54.0

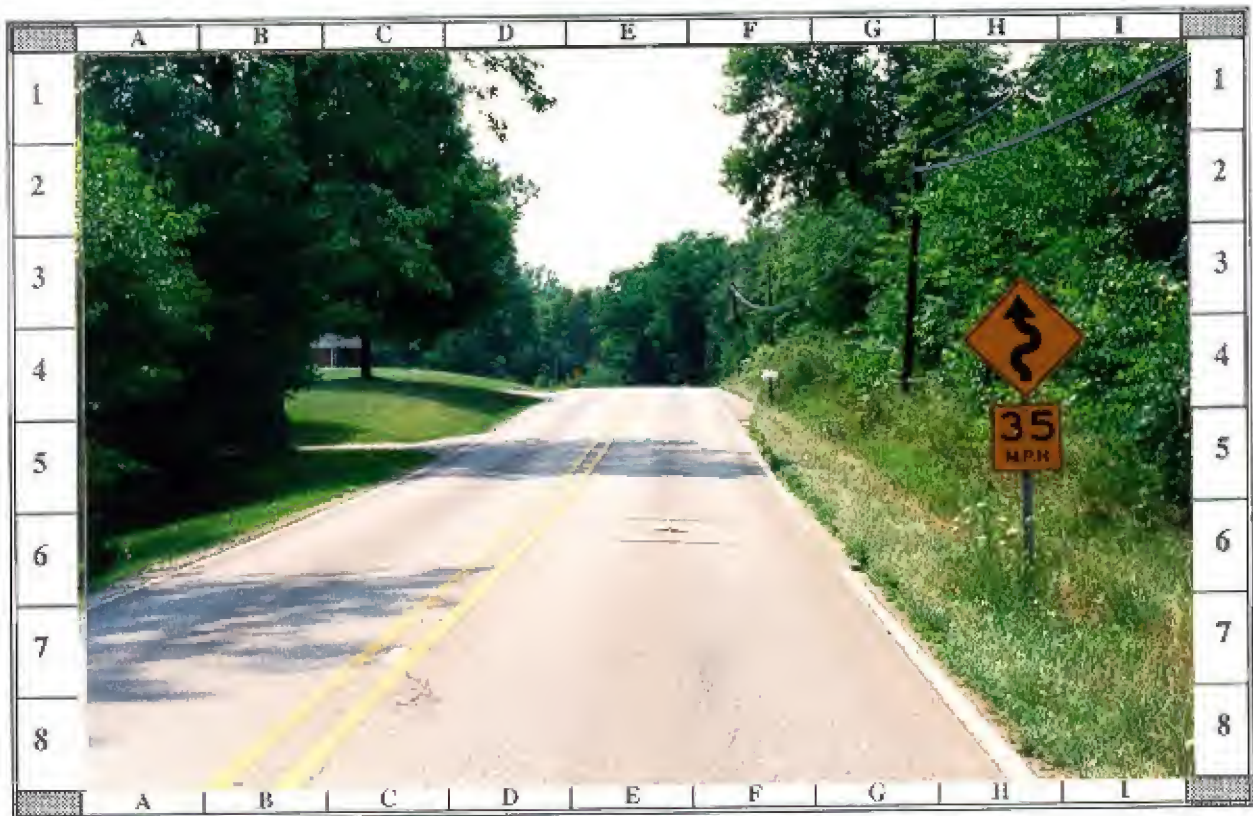
# 01 -- 1994 Oldsmobile Cutlass Ciera S's westward, uphill, path of travel approximately 70 meters east of first harmful event

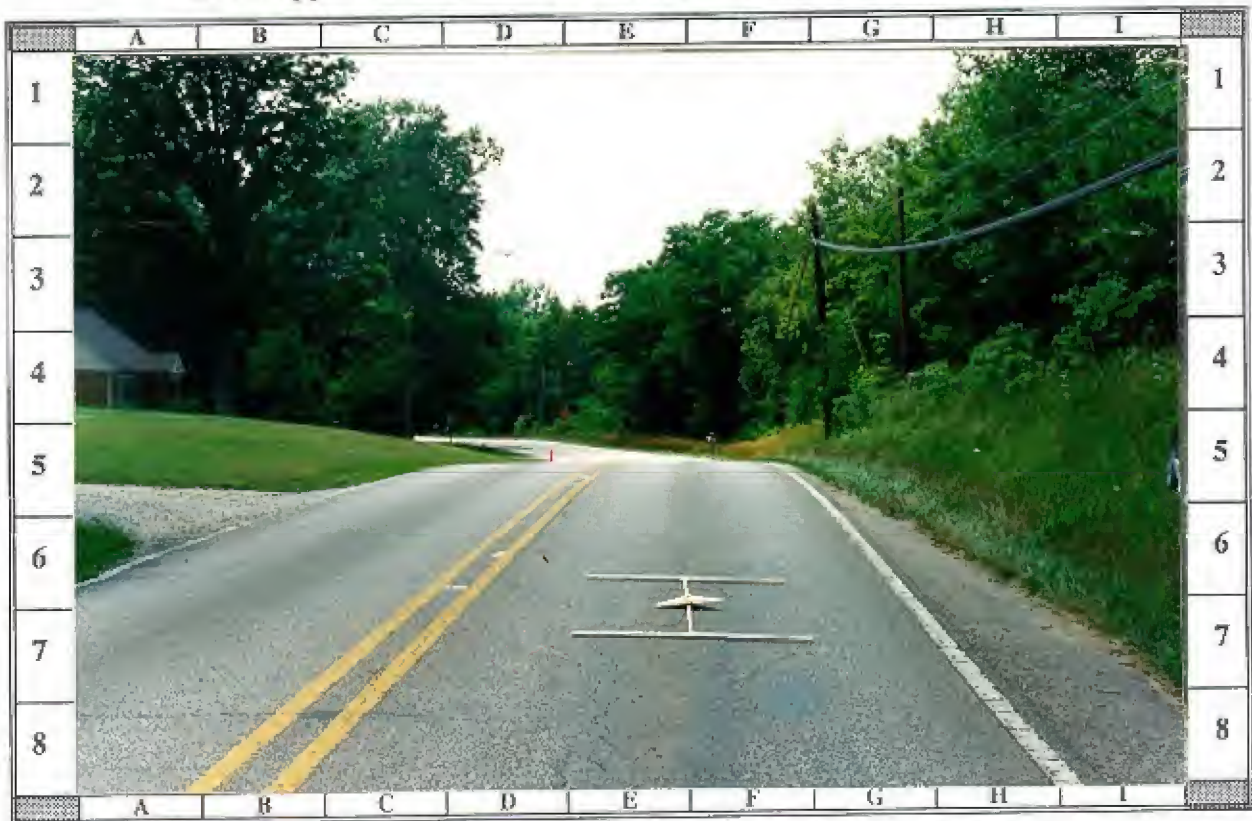
# 02 -- 1994 Oldsmobile Cutlass Ciera's westward path of travel, near hillcrest, approximately 50 meters east of first harmful event

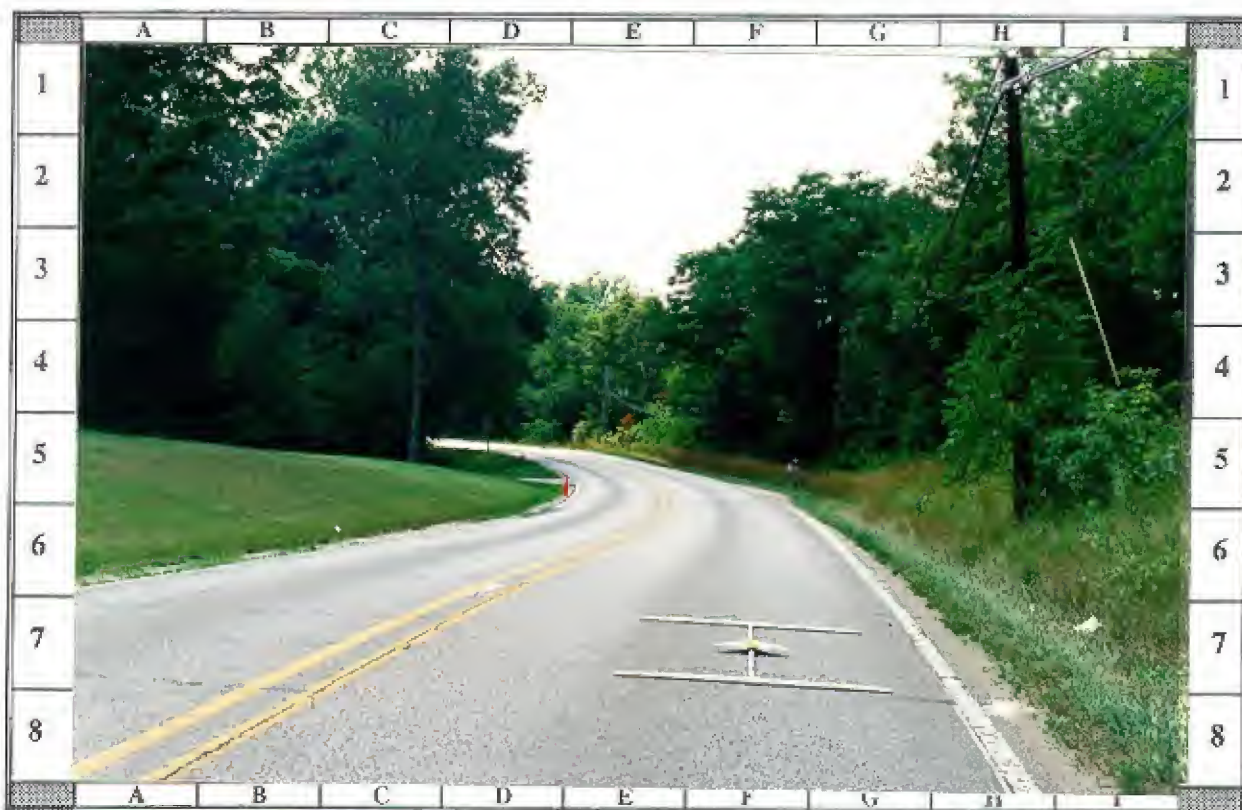
# 03 -- 1994 Oldsmobile Cutlass's westward, downhill, path of travel  
 ~ 20 meters east of POI & west of left-hand curve's beginning

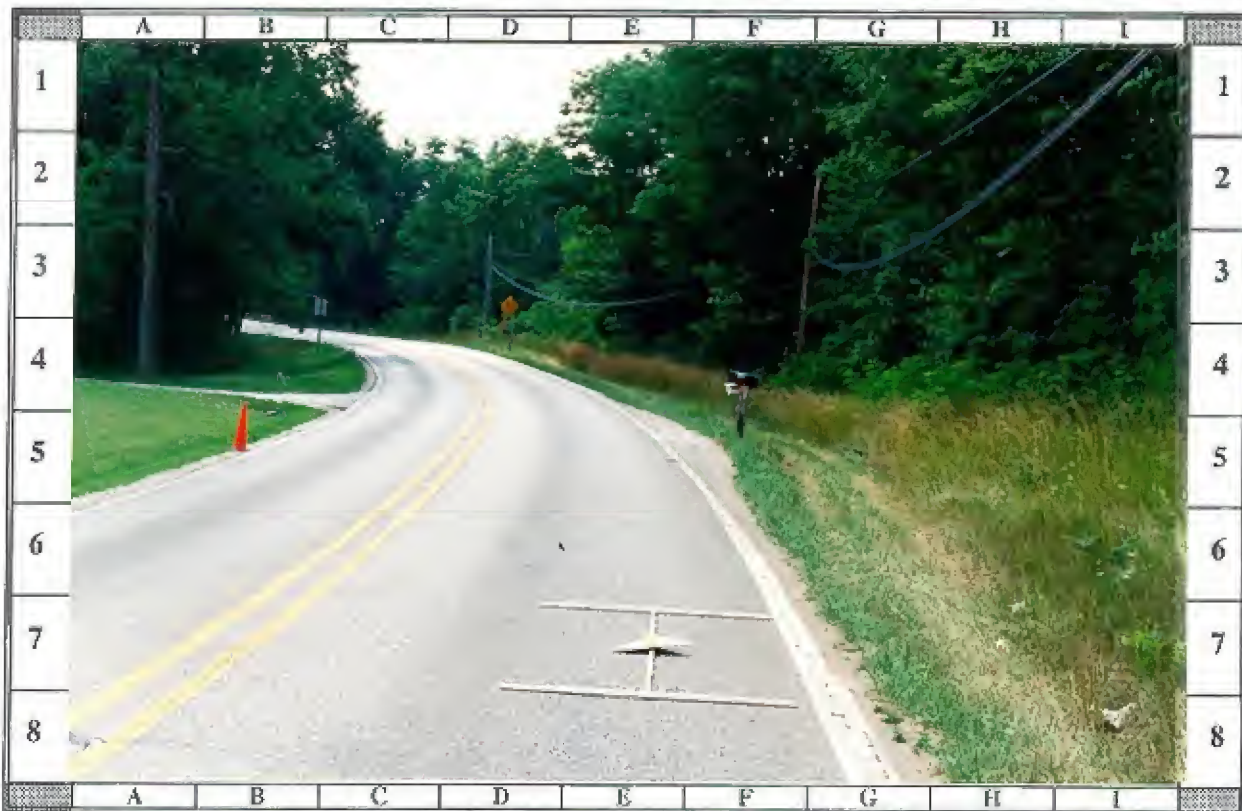
# 04 -- 1994 Oldsmobile Cutlass's westward, downhill (~ 4 %), travel  
 path near beginning of left-hand curve-- ~ 10 meters east of POI

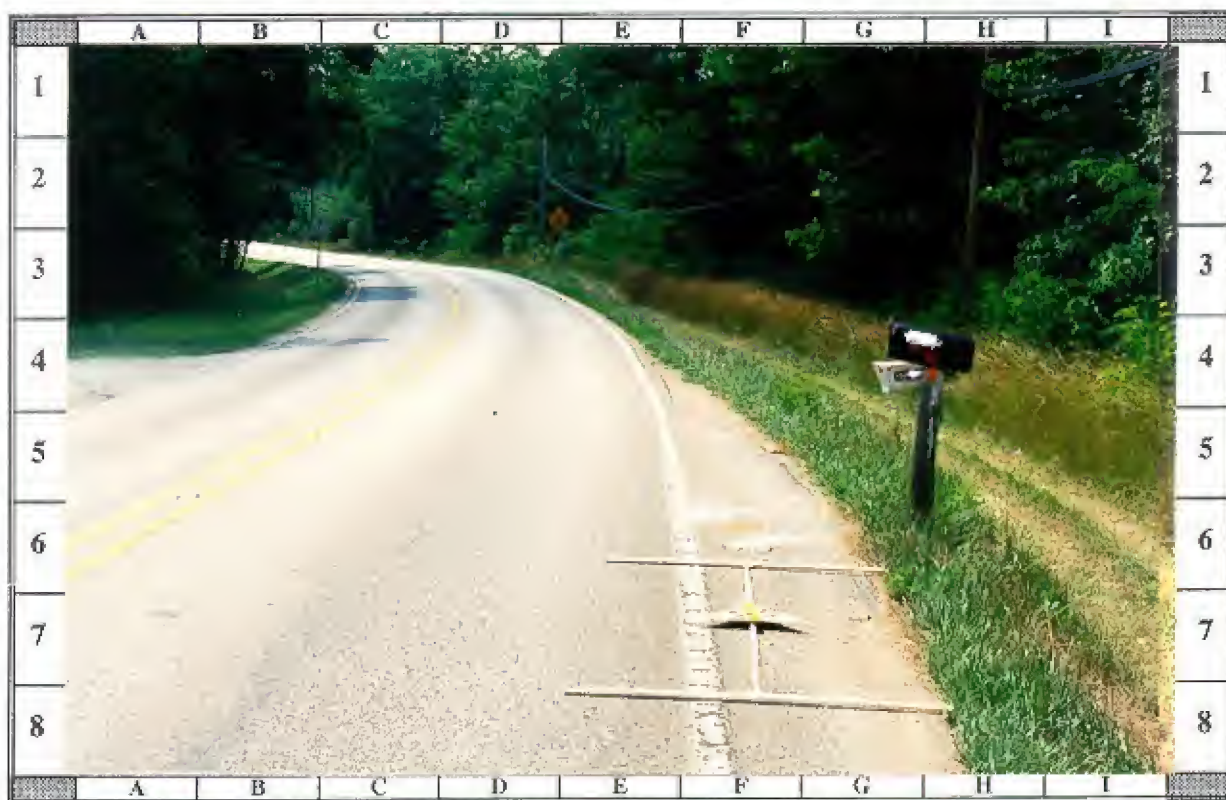
# 05 -- 1994 Oldsmobile Cutlass Ciera's westward travel path just east of its mailbox and paper holder impacts on the north roadside

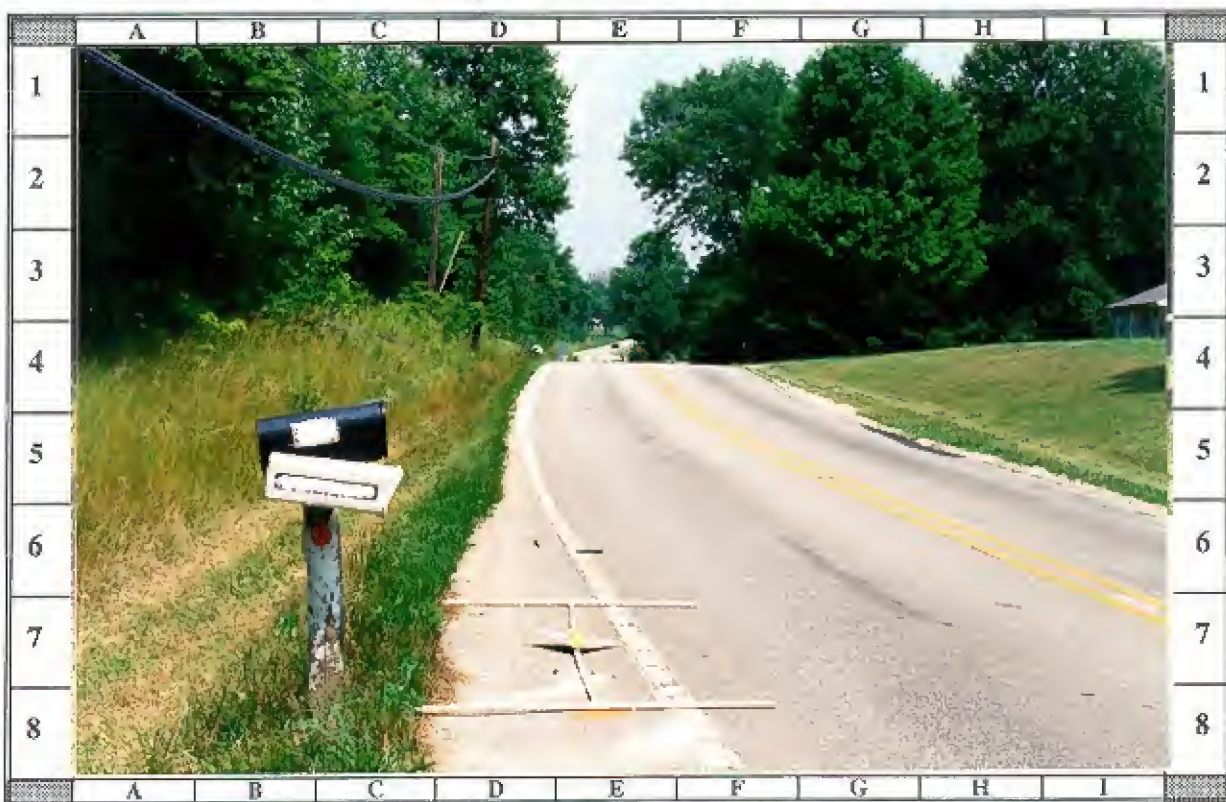
# 06 -- Looking back (eastward) at 1994 Oldsmobile Cutlass's travel path from beyond initial impacts; NOTE: hillcrest and start of curve

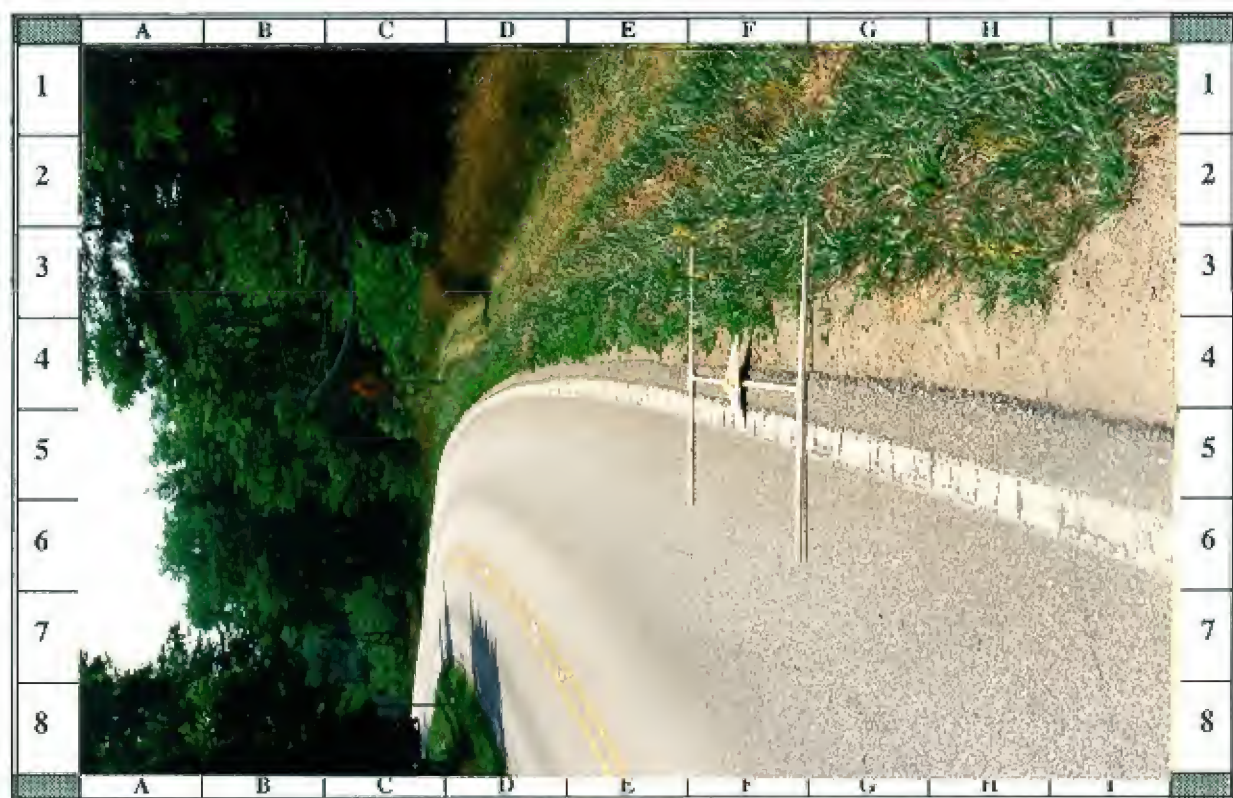
# 07 -- 1994 Oldsmobile Cutlass Ciera's westward travel path between 2nd & 3rd impacts; NOTE: right wheels are tracking along N roadside

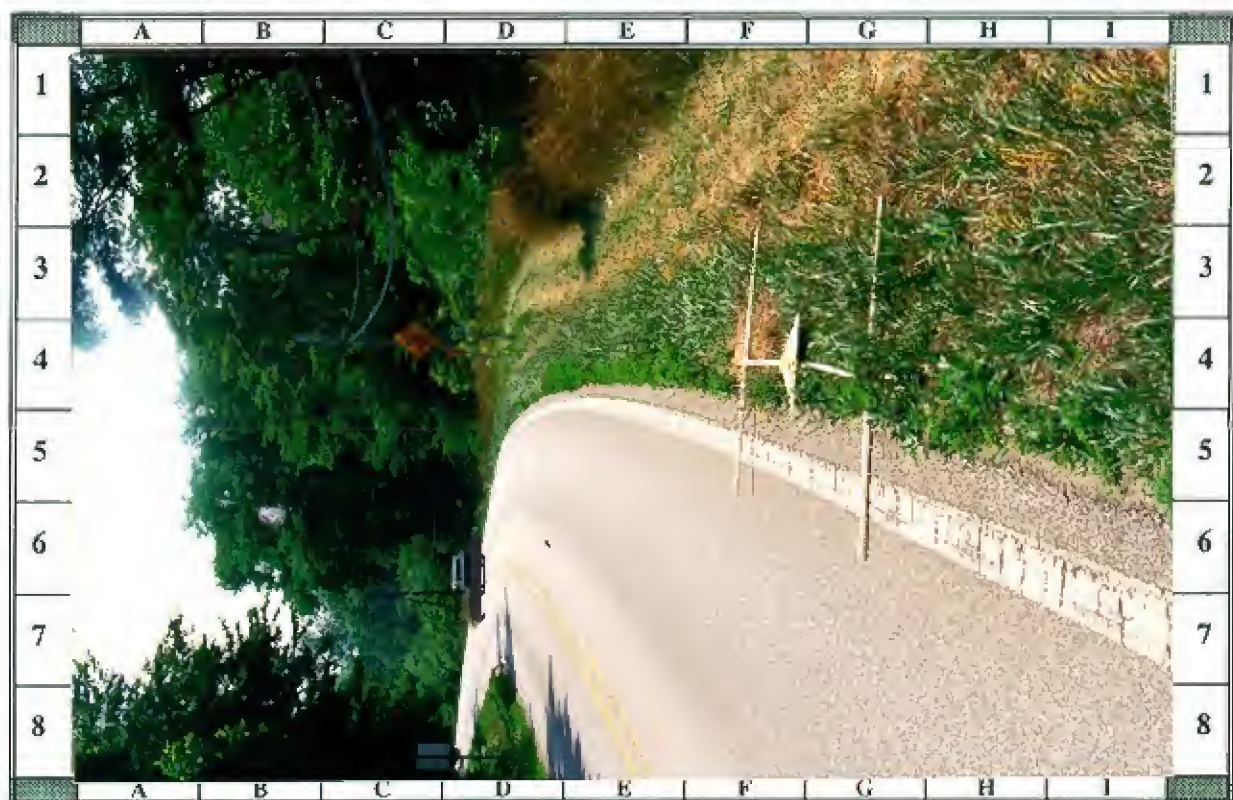
# 08 -- 1994 Oldsmobile Cutlass Ciera's southwestward path of travel ~ 30 meters east of sign posts; NOTE: vehicle is still tracking

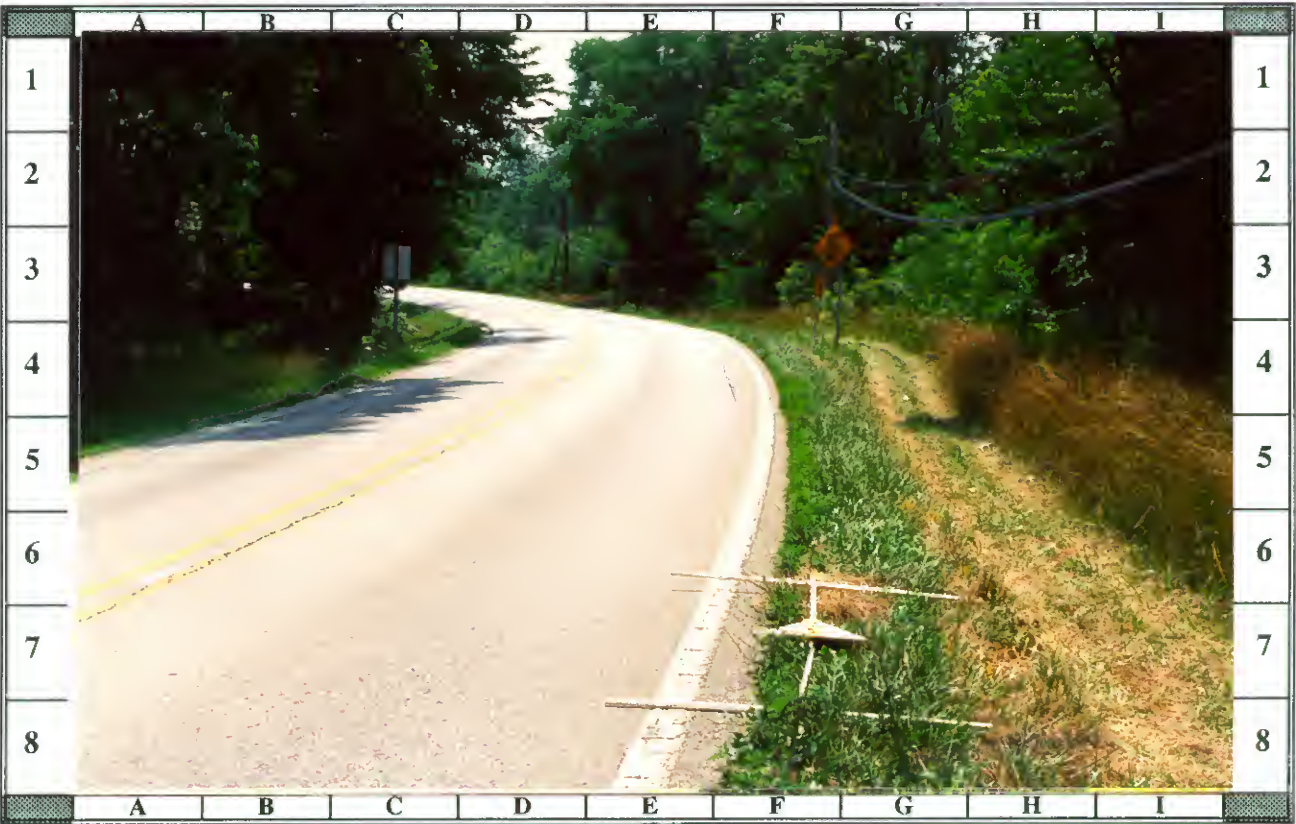
# 09 -- 1994 Oldsmobile Cutlass Ciera's southwestward travel path along N roadside just prior to beginning of counterclockwise rotation

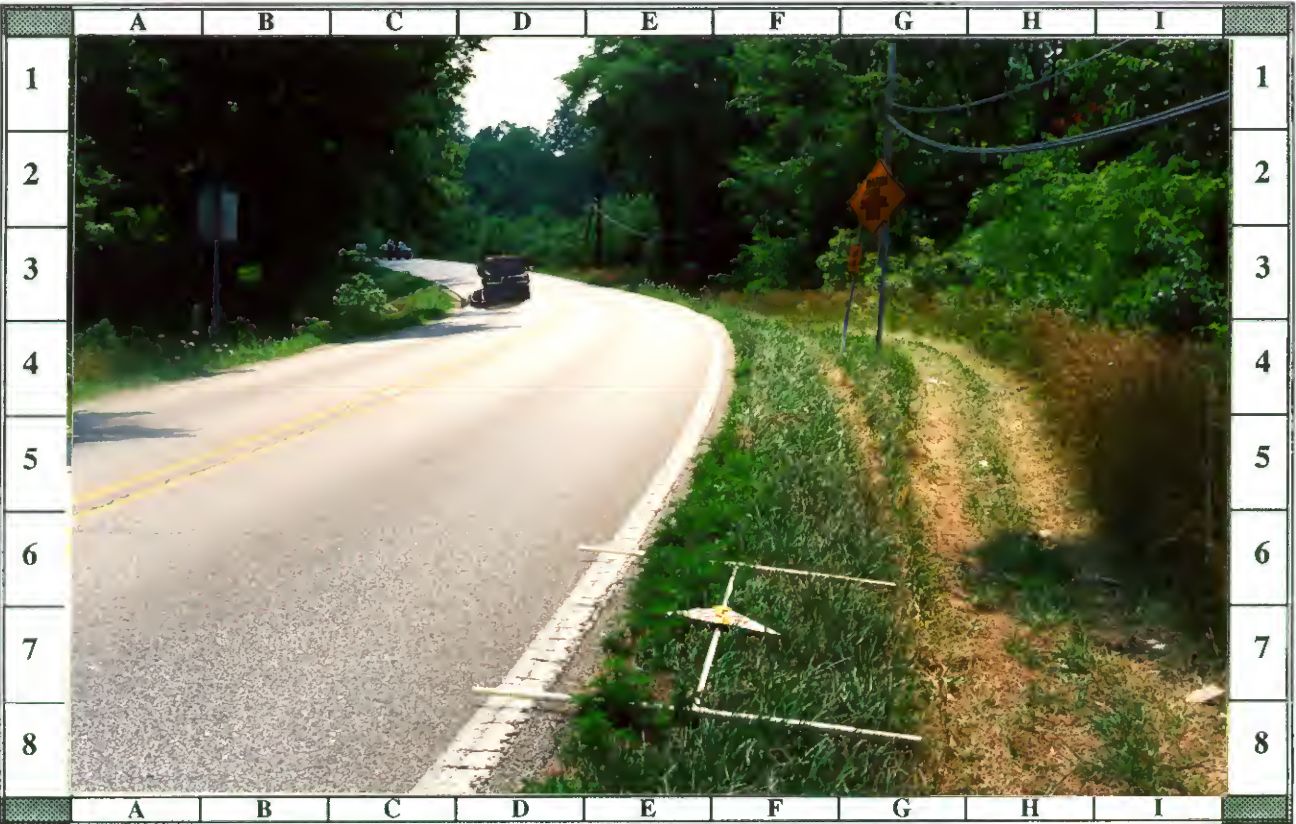
# 10 -- 1994 Oldsmobile Cutlass Ciera's southwestward path of travel ~ 15 meters east of sign posts; NOTE: vehicle is in CCW rotation

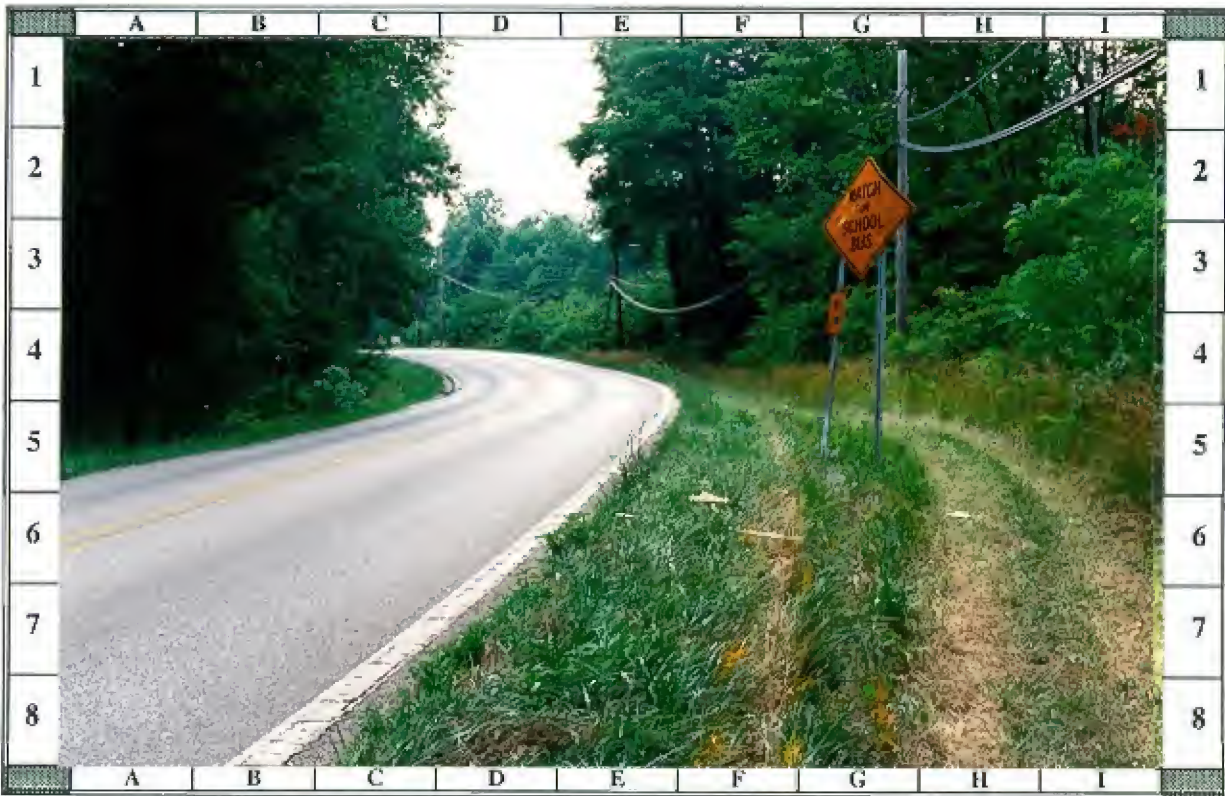
# 11 -- 1994 Oldsmobile Cutlass Ciera's southwestward travel path just prior to impacting left sign post and subwarning sign

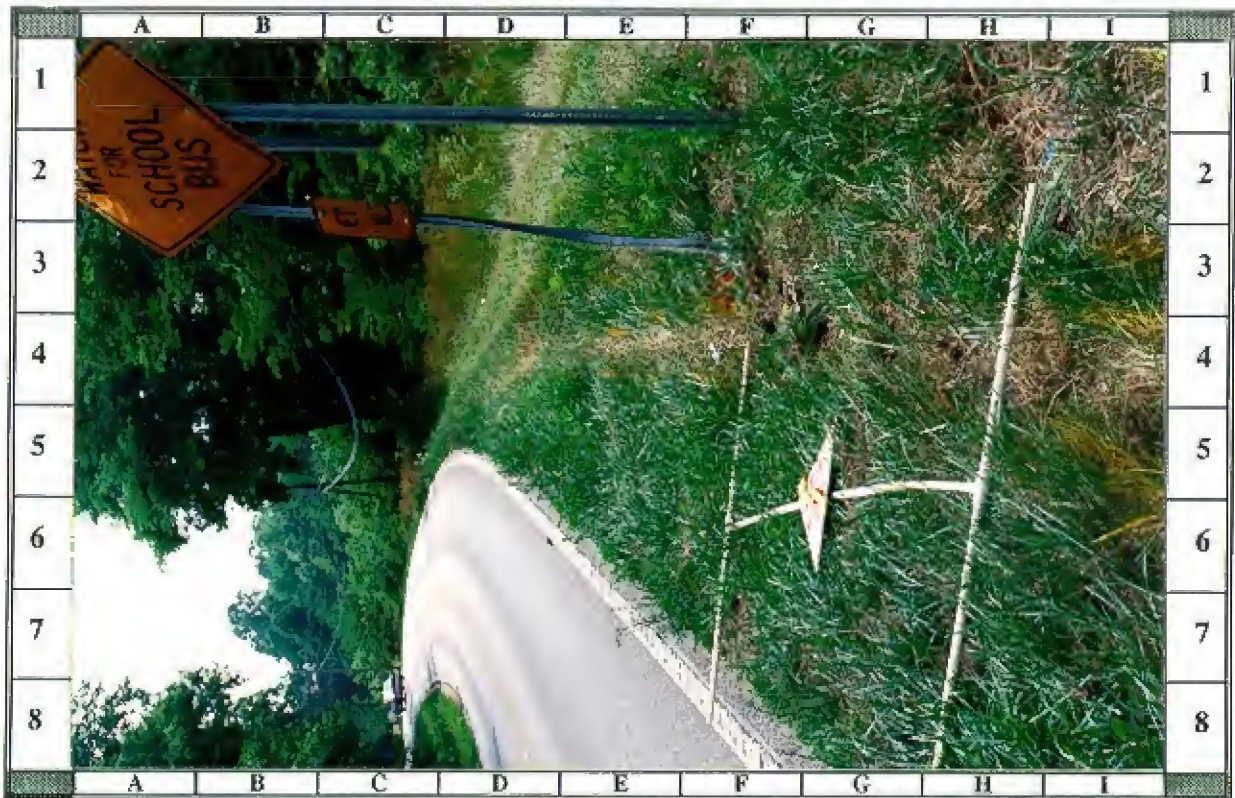
# 12 -- Close-up of 1994 Oldsmobile Cutlass Ciera's third impact with left sign post and subwarning sign (i.e., NEXT 1 MILE)

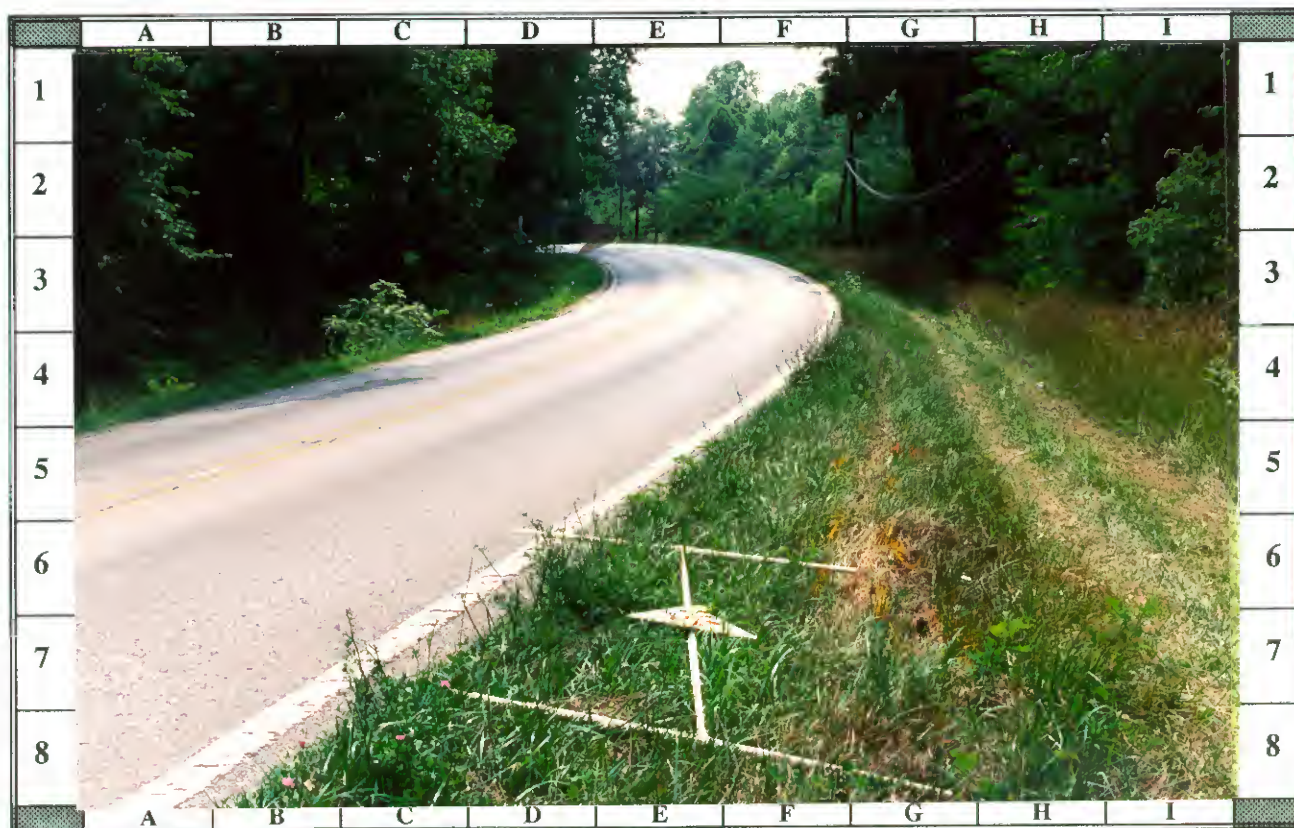
# 13 -- 1994 Oldsmobile Cutlass Ciera continues southwestward along N roadside after striking left sign post and subwarning sign

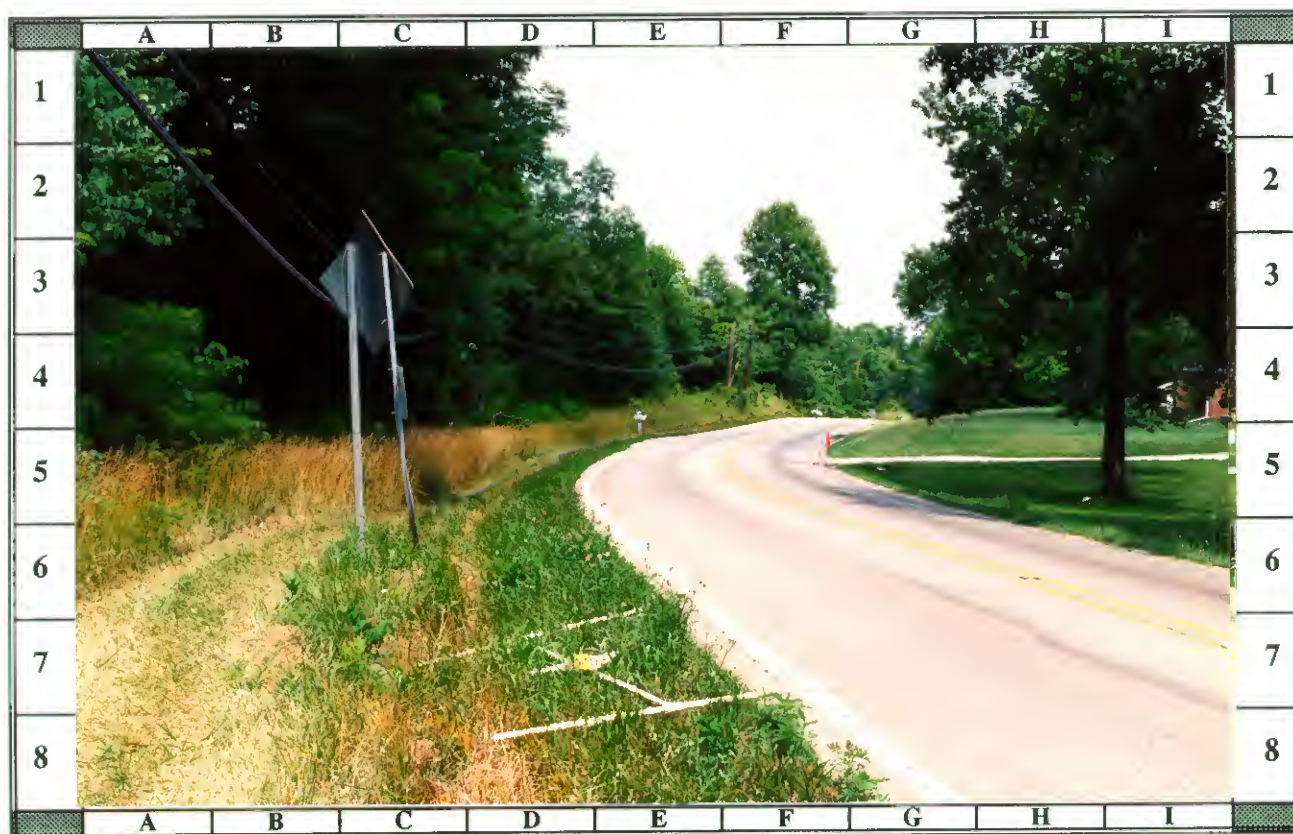
# 14 -- Looking back (northeastward) at 1994 Oldsmobile Cutlass's travel path; NOTE: 2 right side tire yaw marks in grass on N roadside

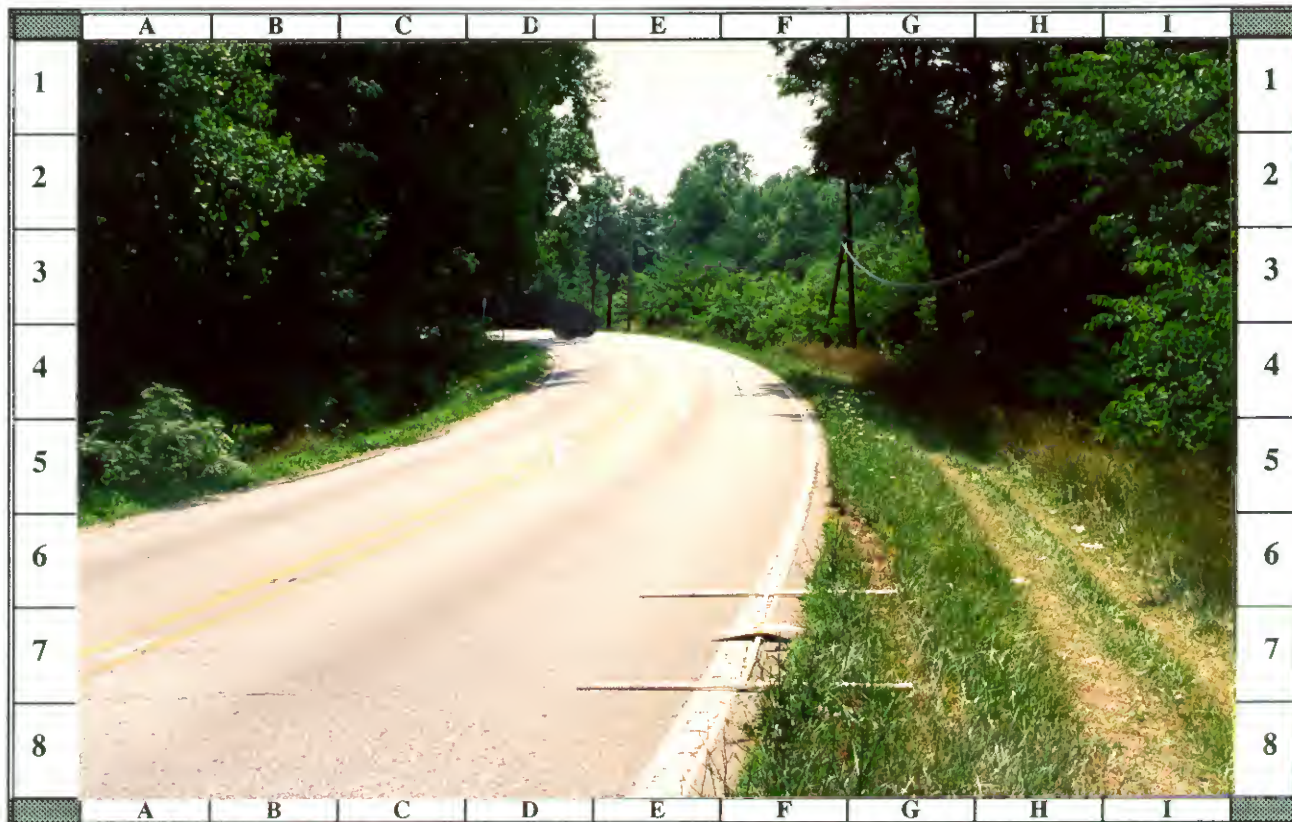
# 15 -- 1994 Oldsmobile Cutlass Ciera's southwestward travel path just prior to re-entering roadway; NOTE: vehicle is tracking

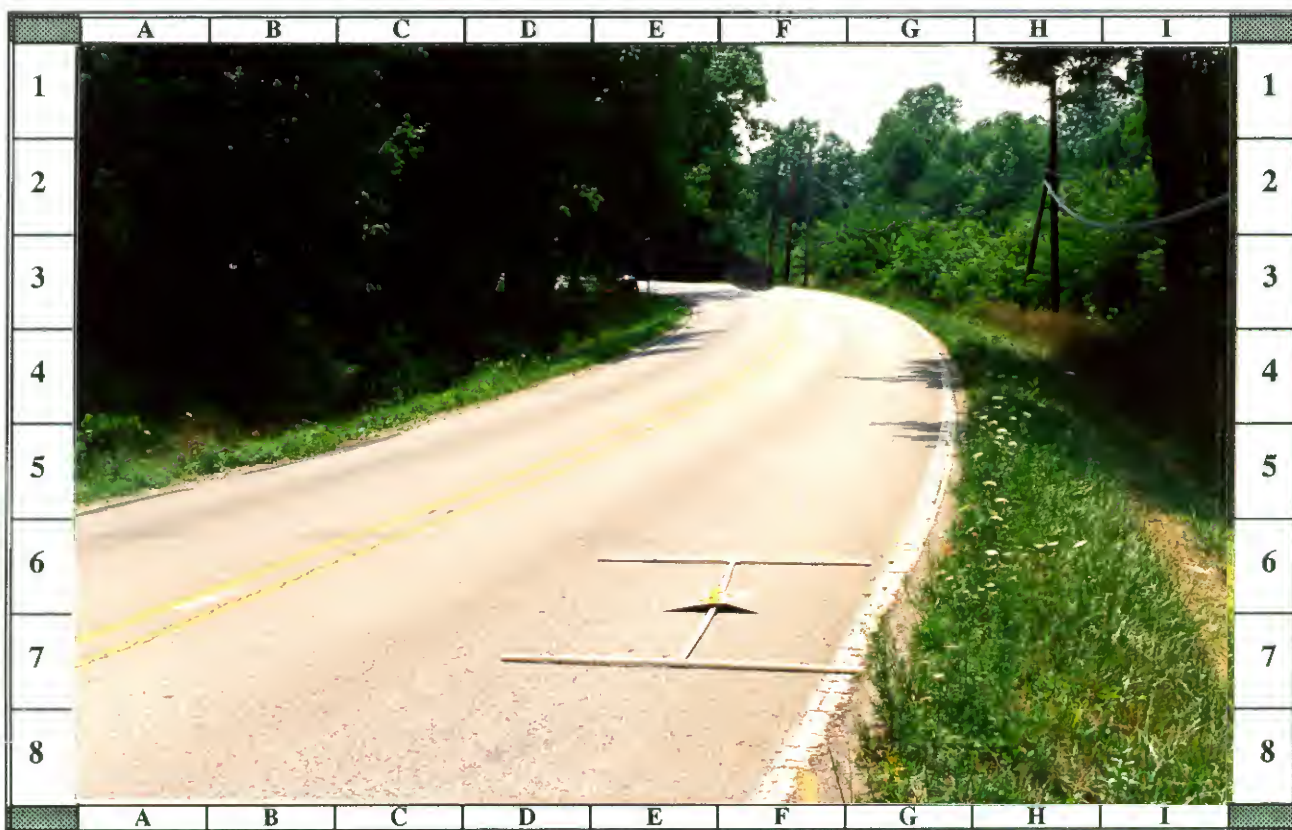
# 16 -- 1994 Oldsmobile Cutlass Ciera heads south across southwestbound and northeastbound travel lanes toward south roadside

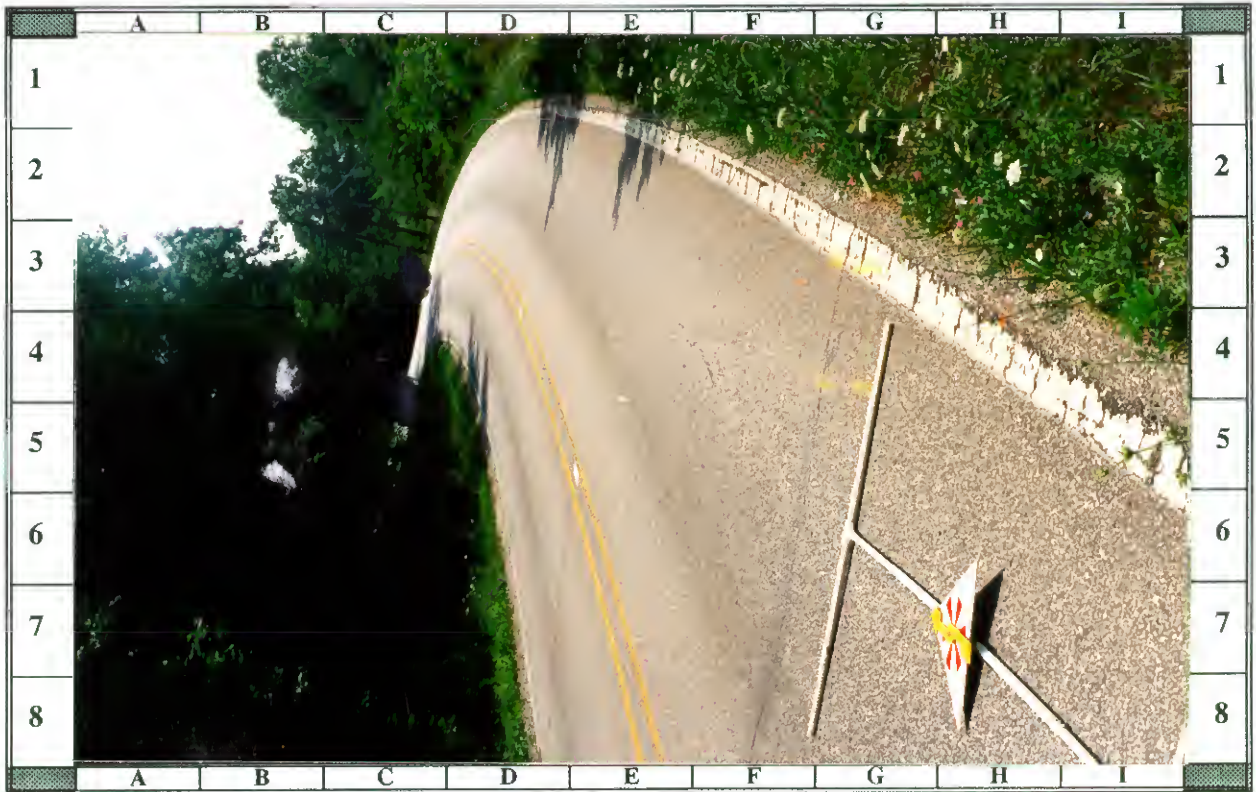
# 17 -- Close-up of '94 Oldsmobile Cutlass Ciera's tire marks on roadway from driver's oversteering (see cells D5, E4, and G4)

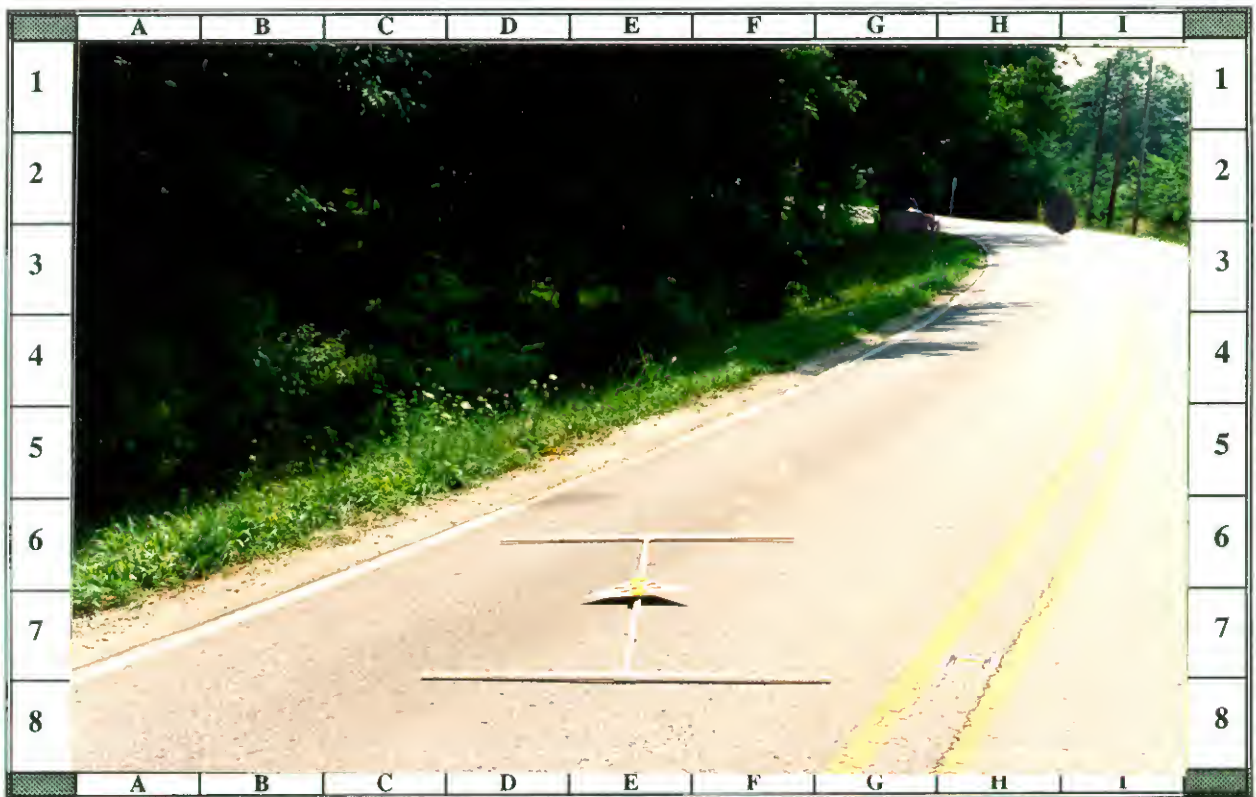
# 18 -- 1994 Oldsmobile Cutlass Ciera's southward path of travel across northeastbound travel lane prior to departing to south roadside

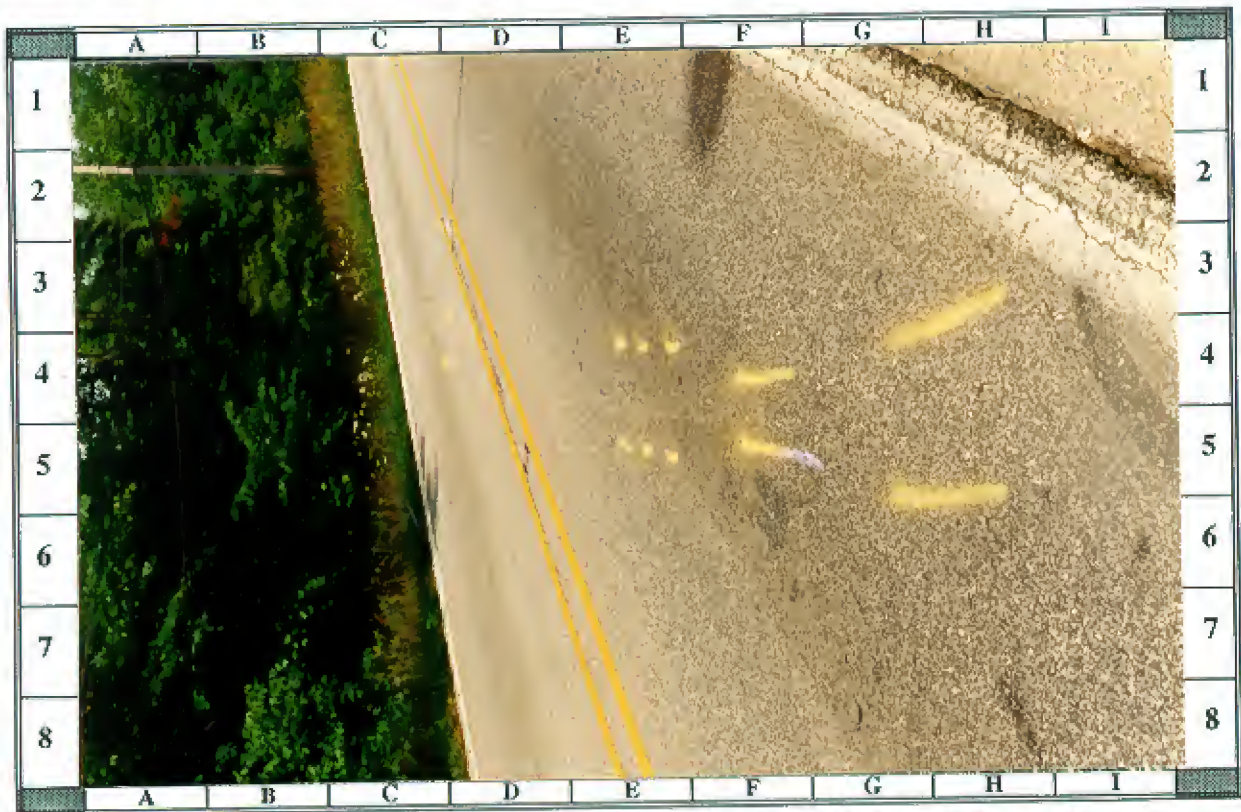
# 19 -- Looking back (northward) at 1994 Oldsmobile Cutlass Ciera's path of travel across roadway; NOTE: highlighted tire marks

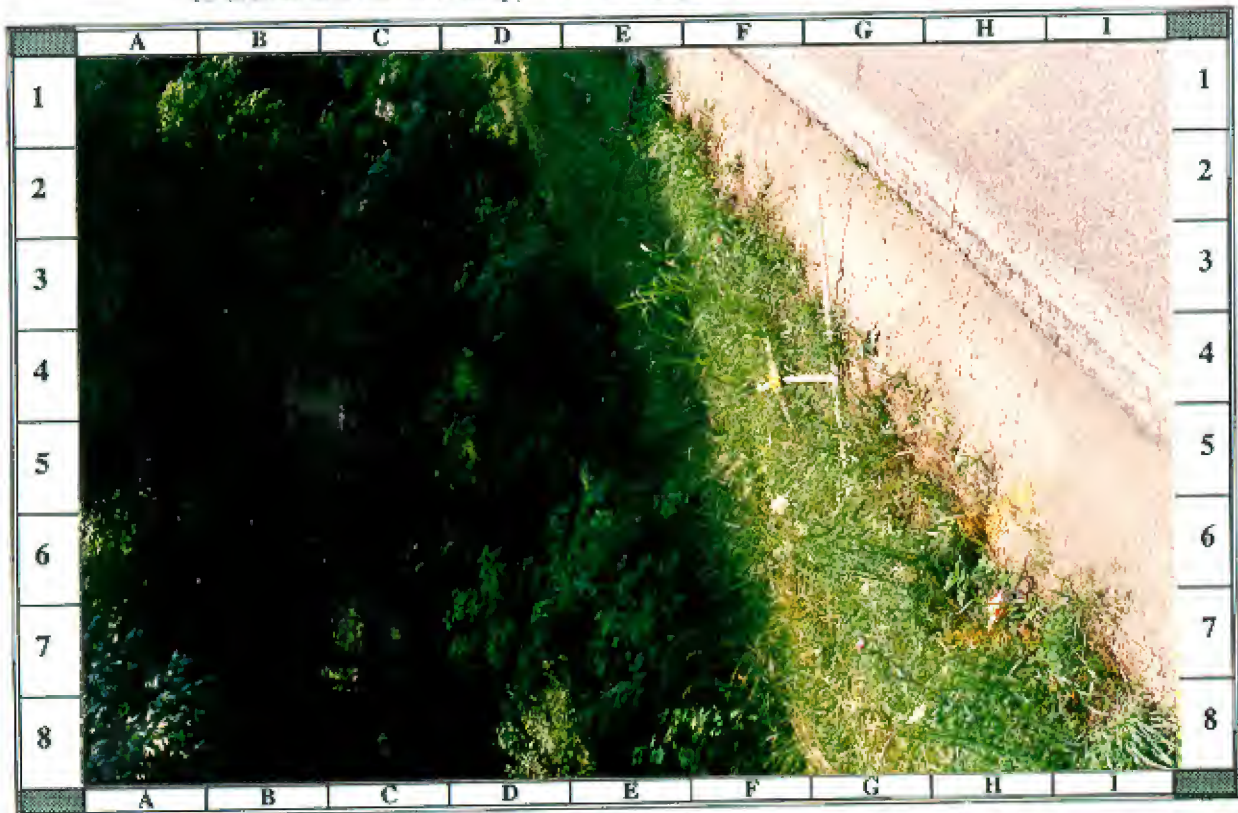
# 20 -- 1994 Oldsmobile Cutlass Ciera's southward path of travel across south roadside ~ 16 meters from impact with large (~37 cm) tree

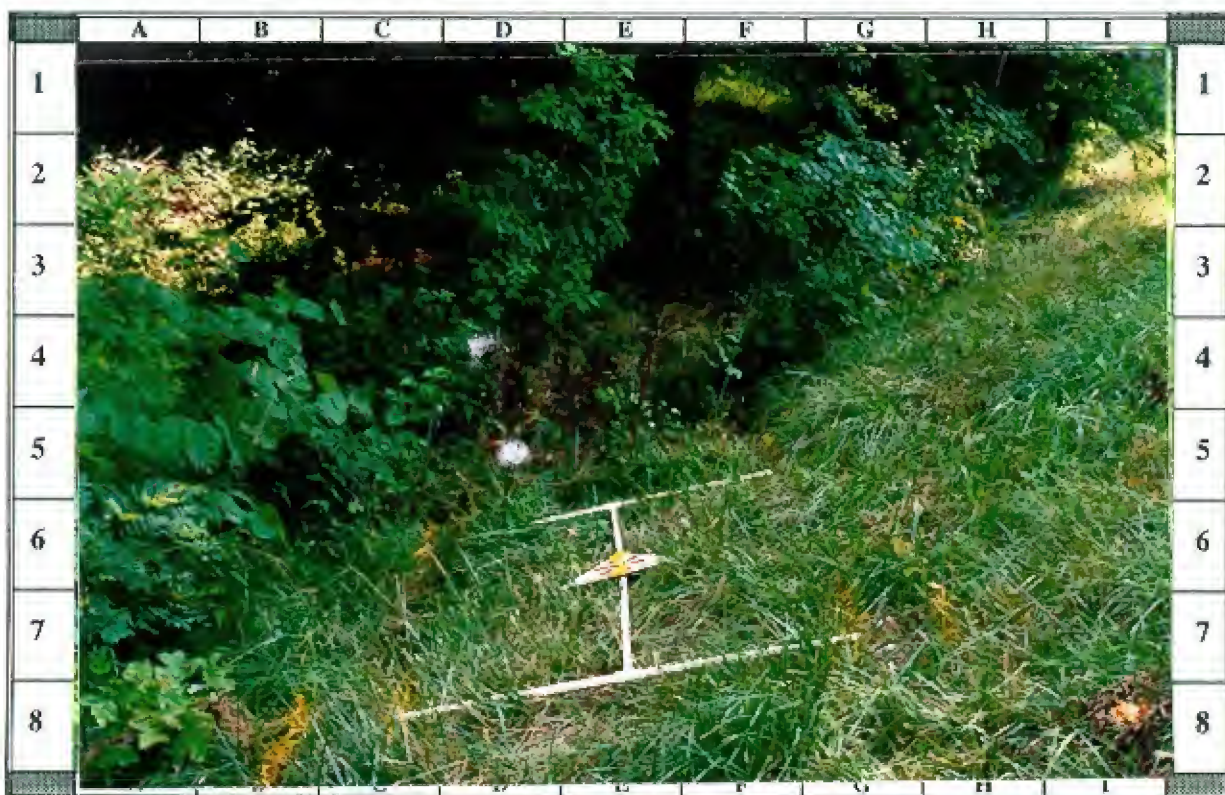
# 21 -- 1994 Oldsmobile Cutlass Ciera's southward travel path down south roadside ~ 12 meters from impact with large (~37 cm) tree
